Immobilized & Imperiled: Crew Safety Endangered in the Wake of Bunker Failures

5th August 2025

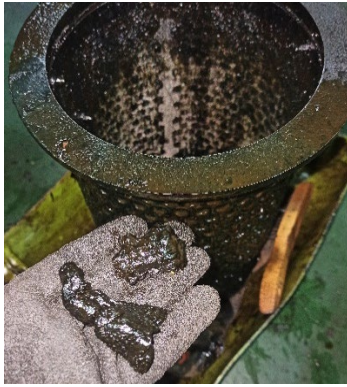
Hard Sludge from the Filters

On 3rd May the tank containing the above grade was stripped to allow for the next grade of VLSFO to be used. Within a few hours, whilst the last of contaminated bunkers were being used, all Main Engine plunger barrels seized, the purifiers clogged, and the filters (fine filter / jet filter/ transfer pump filter) were choked. It was noticed that an unusual and excessive plastic-like, hardened sludge, had formed and this inundated the settling / service tanks and sludge tanks.

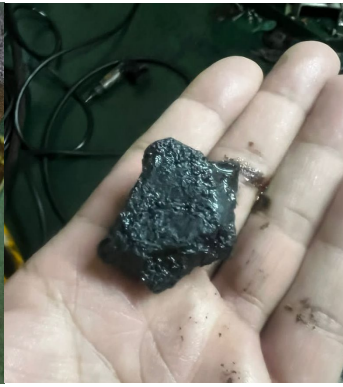
Hard Sludge from the Pipelines

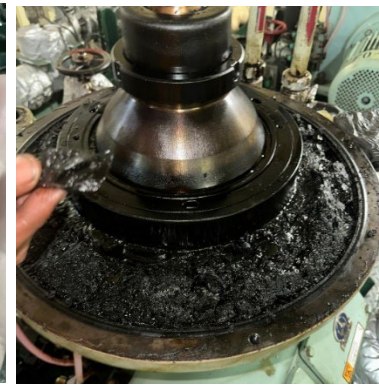
Heavy Sludge in the Purifiers

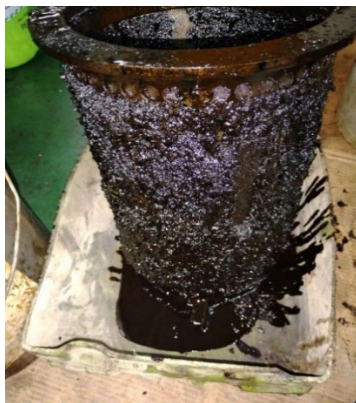
Excessive Filter Clogging

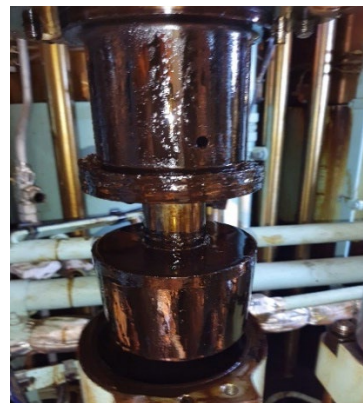
Fuel Plunger Stuck in Top Cover

- The Alkene and Styrene compounds were collectively present in substantial concentration and are known to cause sticking and seizure of fuel pumps plunger and barrel.
- The Phenolic compounds were present in a disproportionately high concentration of 8782 ppm (0.88%). These compounds are known to cause sludge formation in fuel filters / separators and fuel injection issues.
